HISTORIC STRUCTURES REPORT

BRICK WALKS
HISTORIC STRUCTURES REPORT

WILLIAM HOWARD TAFT
National Historic Site

BY MARK A. CHAVEZ
Regional Historical Architect

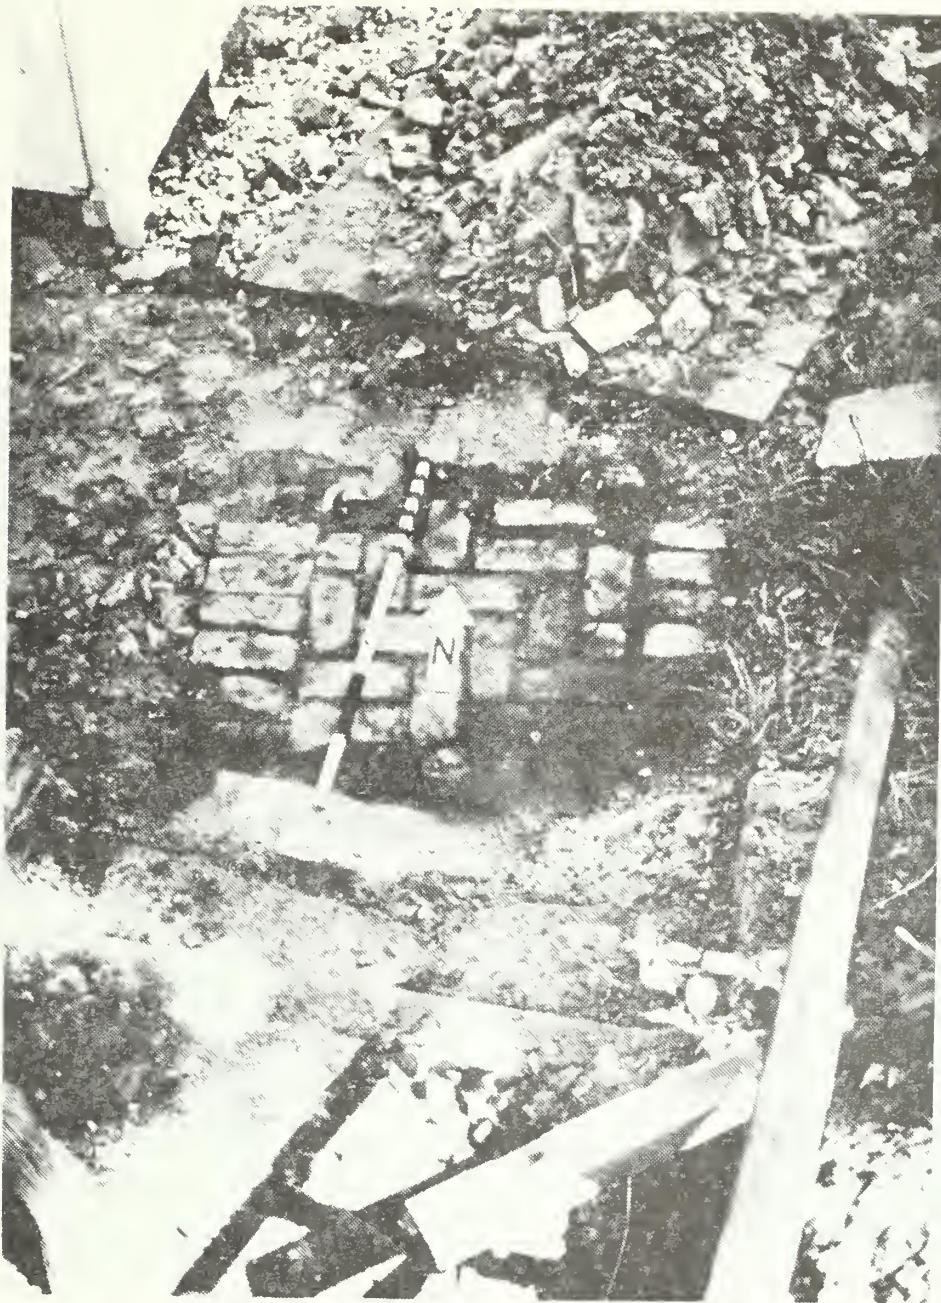
FIGURE 3.3

According to Perry, this section of walkway was non-historic, due to the type of brick used and the pattern (the historic paving had a different edge detail and was set at a diagonal herringbone versus the ninety-degree herringbone pattern seen here). Beneath this paving OhXuxar discovered historic paving (see Figures 3.21 and 3.22).

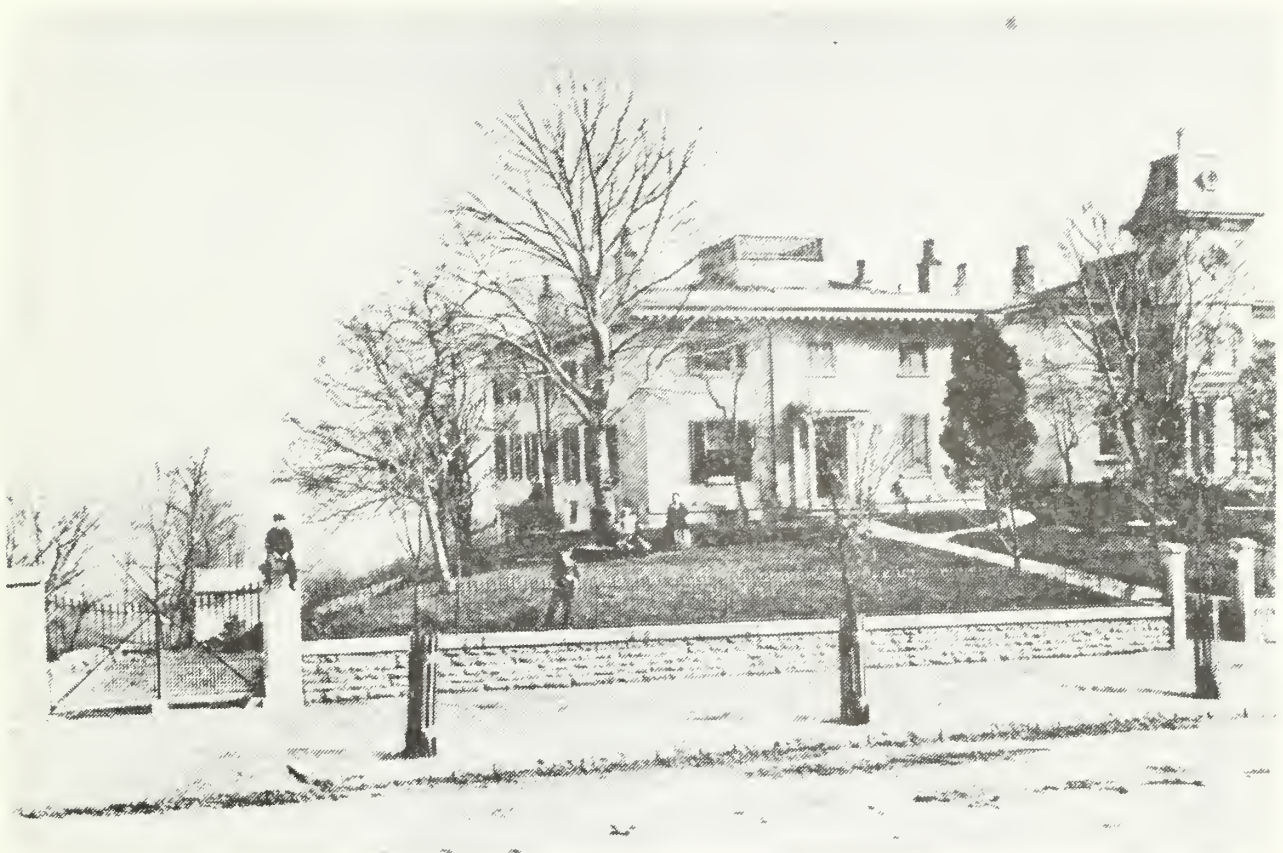
FIGURE 3.9

Note two brick walks and apparent pattern of brick: front walk leading to main entrance and curvilinear walk leading to the south. The brick pattern is herringbone. There does not appear to be a walk leading to the north, however, because of a change in grade, a walk may exist hidden behind a small berm of grass.

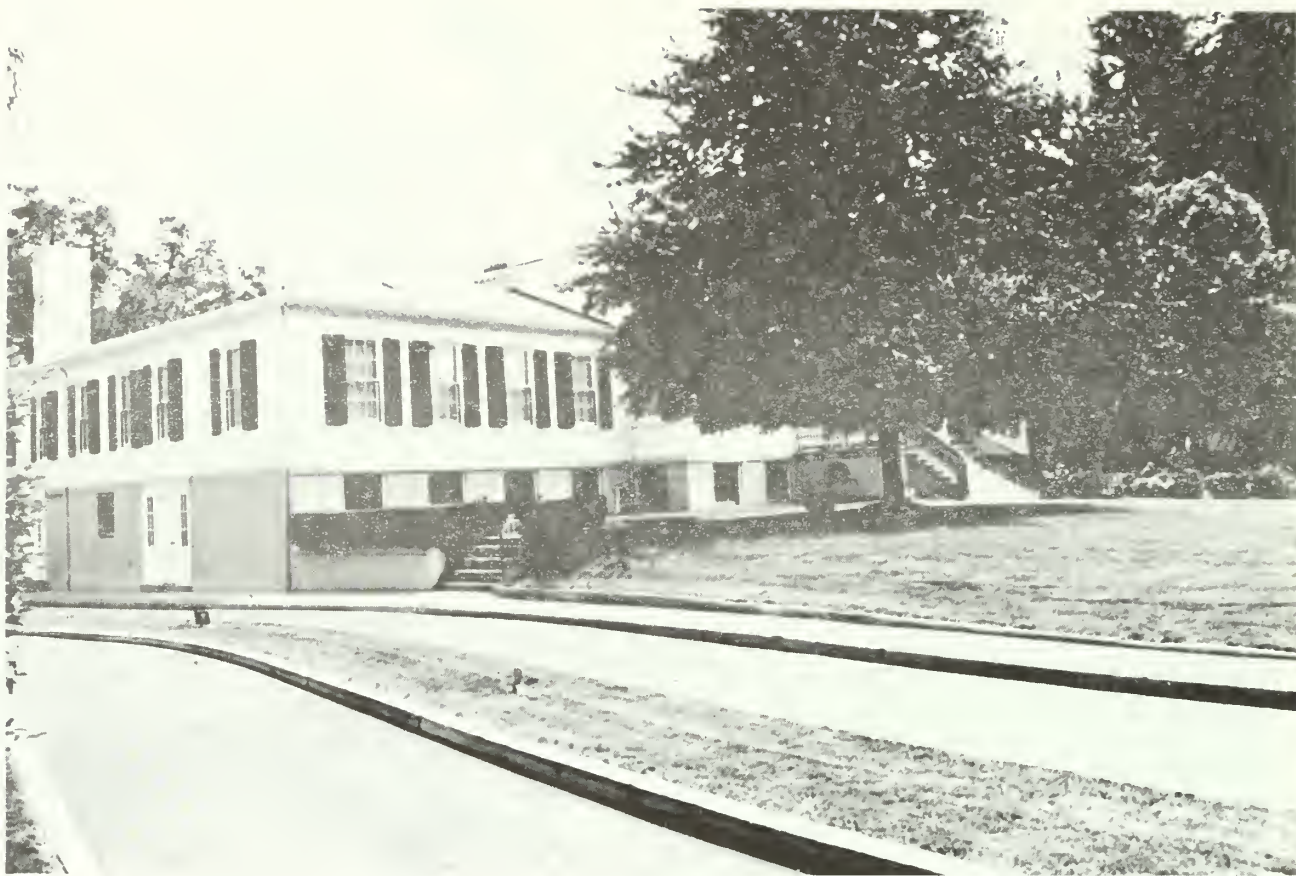
FIGURE 3.20

This photograph was taken to compare possible carriage entrances in support of William Miller's assertion that a similar condition existed at both this site and the William Howard Taft National Historic Site property. The conclusion is that the sites are indeed different, and the entrance viewed in this photograph is a modern addition.

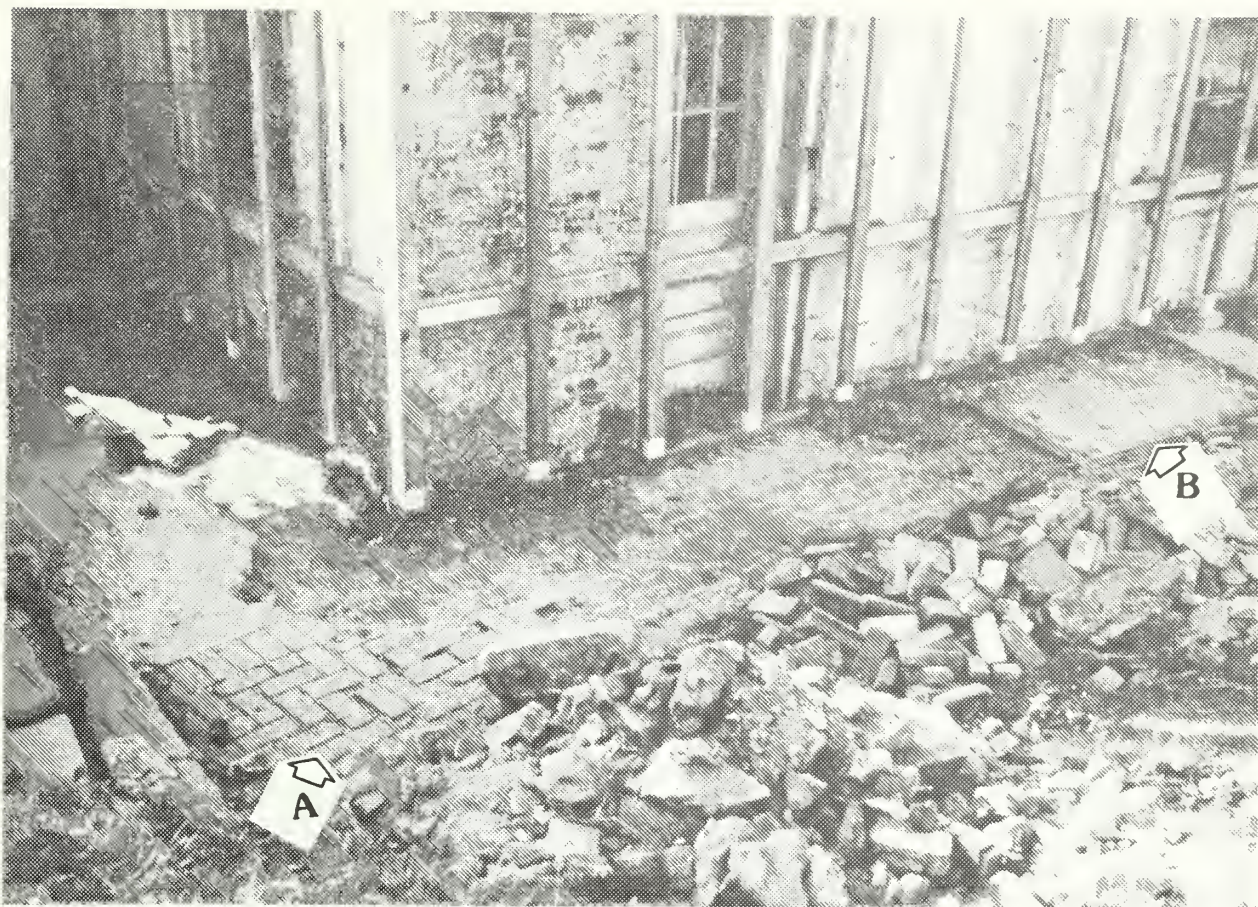
FIGURE 3.21

B) Beneath the paving shown at "A" was a layer of historic paving, similar to the section which is seen about six feet north of the east door. Note that there would have been at least one step down from this door to the walkway. Figure 3.22 is a detail of this area.
